26-28 COURT STREET/2-6 BROAD STREET PRELIMINARY INVESTIGATION

Freehold Borough, NJ

March 2, 2020

Block: 36

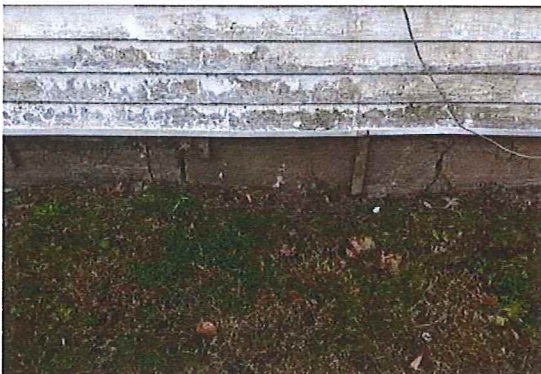
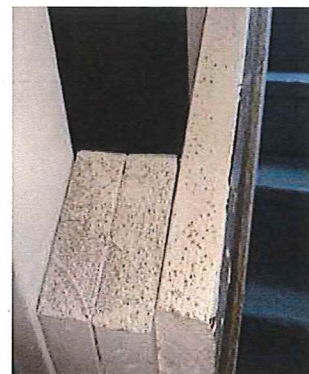
Figure 3. Cracked Foundations & Basement Flooding

Every primary structure has cracks in the foundation. The full extent of these cracks is unknown, but they are visible to the naked eye both in the basements and on the exterior of all four buildings. These foundational issues have led to significant flooding in all of the basements, resulting in water damage and mold build-up to varying degrees. As time goes on, these issues will only continue to worsen, making substantial renovation of the structures even less financially feasible in the future.

Cracked foundation at 4 Broad Street

Basement Flooding & Mold Build-Up at 26 Court Street

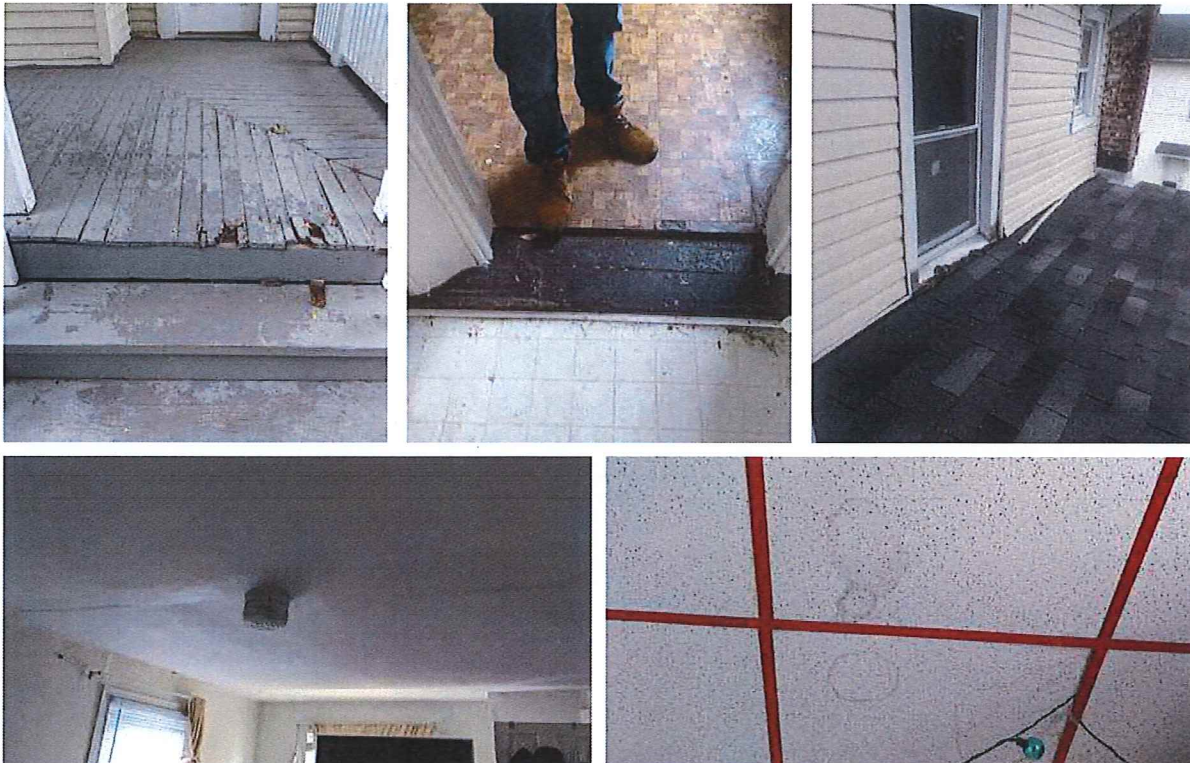
Figure 6. Safety & Sanitary Issues at Block 35, Lot 7 – 2 Broad Street

While the floors in all of the buildings were unstable to varying degrees, the floors in 2 Broad Street were especially concerning. Not only were they often left unfinished, which creates the threat of tripping on uneven floors, the floors in 2 Broad Street were noticeably uneven, and more troubling, bowed and bent as one walked upon them. This indicates that the floors are lying upon support beams that are giving way, and that the floors themselves are bowing, likely due to water damage, age, and a lack of maintenance over the years. In fact, according to the property owner and one of the tenants of the occupied unit in 2 Broad Street (who was there during the site visit), the ceiling in the living room collapsed roughly a year ago. This ceiling collapse was likely due to the same issues causing the floors throughout the rest of the building to bend, bow, and slope: water damage, age, and lack of maintenance.

2 Broad Street also has one of the worst roofs of any of the buildings, with pieces of roof trim falling off and in need of repair/replacement, and shingles that routinely fall off during wind events and storms. Not only do these issues pose a threat to 2 Broad Street's tenants in the form of roof leaks and further water infiltration into the building, they also pose a threat to the broader community. Falling shingles or pieces of wood from the building's roof trim could strike and injure pedestrians, motorists, or others in the area during a storm or wind event.

Finally, while there was water damage in all of the buildings in the Redevelopment Area, it was most prevalent in 2 Broad Street. Beyond mold build-up in the basement as illustrated in **Figure 3 on page 7**, there was evidence of water damage all throughout the building, which increases the likelihood that there is mold throughout the structure that is yet to be discovered.

Rotting wood on front porch (top right); unfinished floors (top center); dilapidated roof (top left); repaired collapsed ceiling (bottom left); water build-up (bottom right).

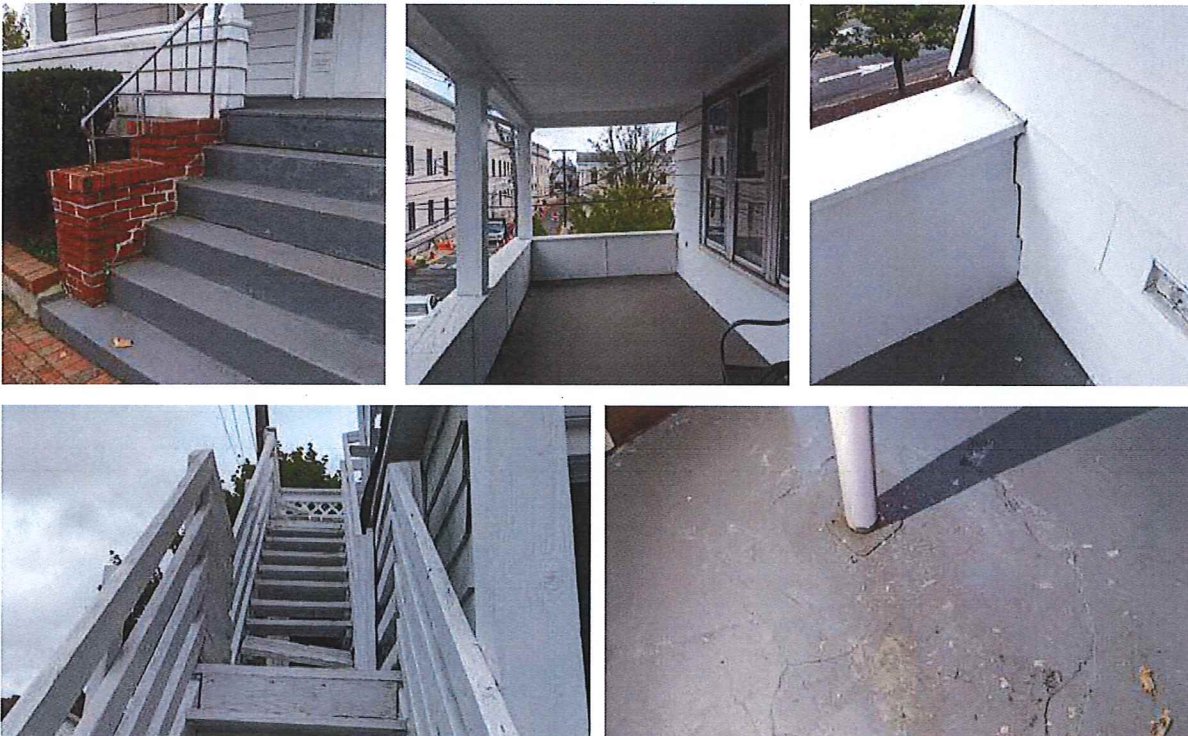
Figure 7. Safety & Sanitary Issues at Block 35, Lot 9 (9.01) – 26 Court Street

26 Court Street also exhibited additional unique issues that make it a particularly unsafe dwelling in which to live or work. For example, the steps up the building's front porch are too steep. Beyond not being ADA-compliant, these steps are difficult for even the able-bodied to climb and pose a serious injury risk to tenants and visitors. According to the property owner, a previous tenant fell down the steps, broke her hip, and needed to be hospitalized.

The biggest issue at 26 Court Street is the exterior staircase, which serves as the fire escape for the units on the back of the building adjacent to the parking area. This staircase has clearly not been renovated in a long time, and several of the steps are broken or missing altogether. Not only does this staircase pose a major risk of tripping, it also poses the danger to those who climb it of falling from height, which could result in serious injury or even death.

Almost equally concerning is the fact that there are two metal supports in the basement that were clearly placed long after the building itself was constructed, and which seem to be holding up the basement's ceiling and preventing it from collapsing. This is evidenced by the fact that the concrete floor underneath these supports has cracked and sunk almost an entire inch.

Steep steps to front porch (top right); sloping balcony giving way (top center & left); dangerous exterior staircase (bottom left); support beam in basement pushing into and cracking concrete (bottom right).

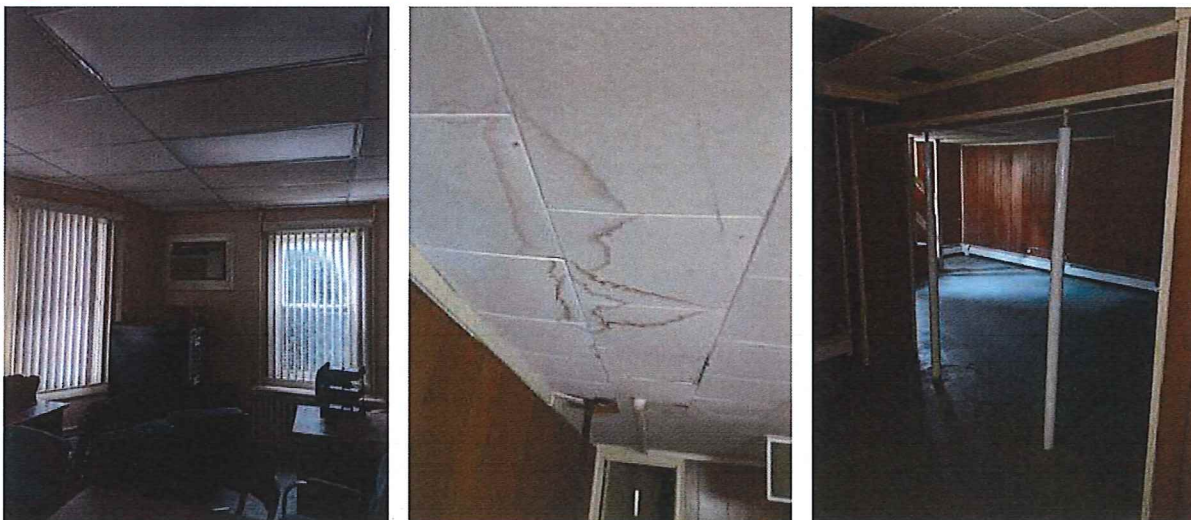
Figure 9. Broken Windows, Doors, & Walls

Leftover furniture and office supplies (left); water damage on ceiling and current state of former basement commercial space (center & right).

Additionally, the basement commercial space has fallen into a serious state of dilapidation as the building has deteriorated over the last several years. Beyond the water damage and sinking support beams discussed in **Section 4.3.a. Block 36, Lots 5 (5.01), 6 (6.01), 7, & 9 (9.01) on page 7** and **Section 4.3.c. Block 36, Lot 9 (9.01) - 26 Court Street on page 11**, this entire space is essentially unusable due to the cracked foundations and flooding in this building's basement, which would be majorly expensive to repair.

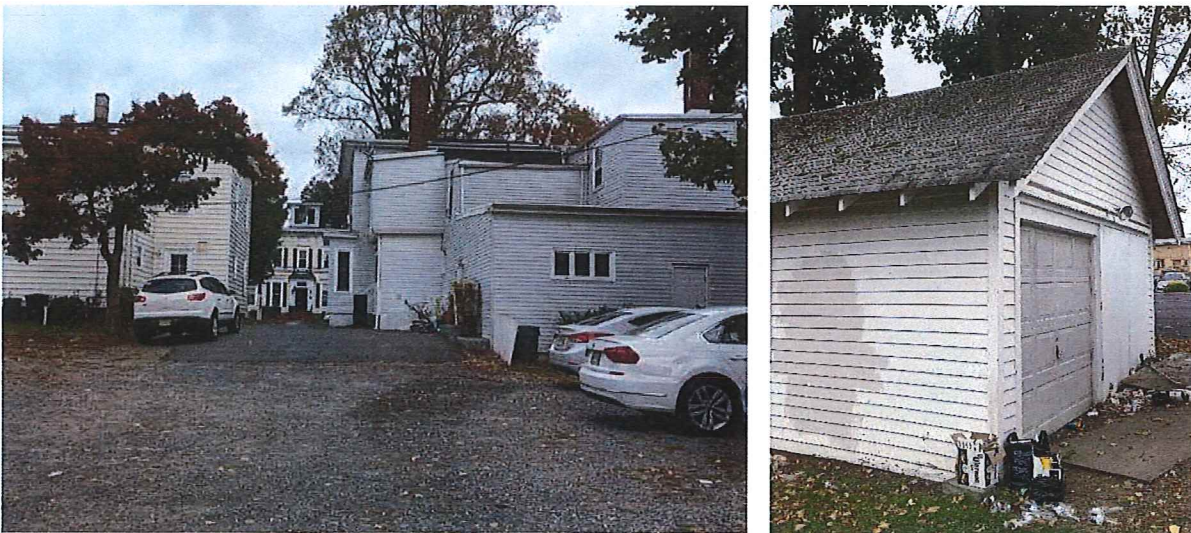
Figure 11. Unregulated Parking Area & Outbuilding

Unregulated parking area on Block 35, Lots 5 (5.01) & 6 (6.01) (left); outbuilding on Block 35, Lot 5 (5.01) (right).

- Illegal squatting and other usage of the outbuilding. On the of the site visit, there were piles of beer bottles, half-finished bags of chips, and other paraphernalia strewn about the front of the outbuilding, indicating recent use as a hangout or party destination. Conversations with the property owner and neighbors confirmed this to be a repeat location for such activities. Homeless individuals are also frequently caught squatting in the building, and the Freehold Borough police department must regularly be called in to remove these individuals.

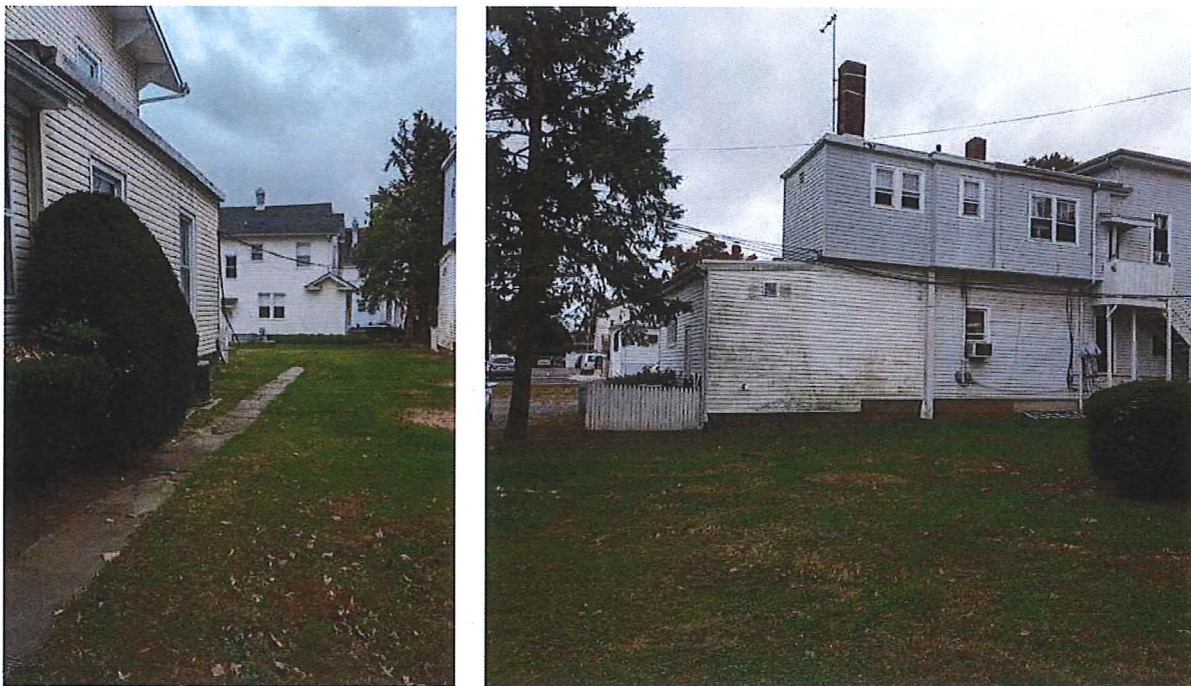
Figure 12. Block 35, Lot 7 Configuration

There currently is no parking area on Block 36, Lot 7, which is required by **Section 3.03.04(i) "Parking"** of the 2008 "Visioning & Revitalization Plan for the Freehold Center Core Redevelopment Plan Area." This plan serves as the existing zoning and thus regulates parking for all of the lots in the study area. There is also not enough space to create a parking area within the bounds of Block 36, Lot 7, which means that current tenants and visitors to the property must either park on the street, or in the unregulated and unpaved lot that spans Block 36, Lots 5 (5.01) and 6 (6.01). This lack of parking means that, in its current configuration, Block 36, Lot 7 is a non-conforming use under the existing zoning.

Block 35, Lot 7 is too small to provide space needed for parking pursuant to Freehold zoning documents.

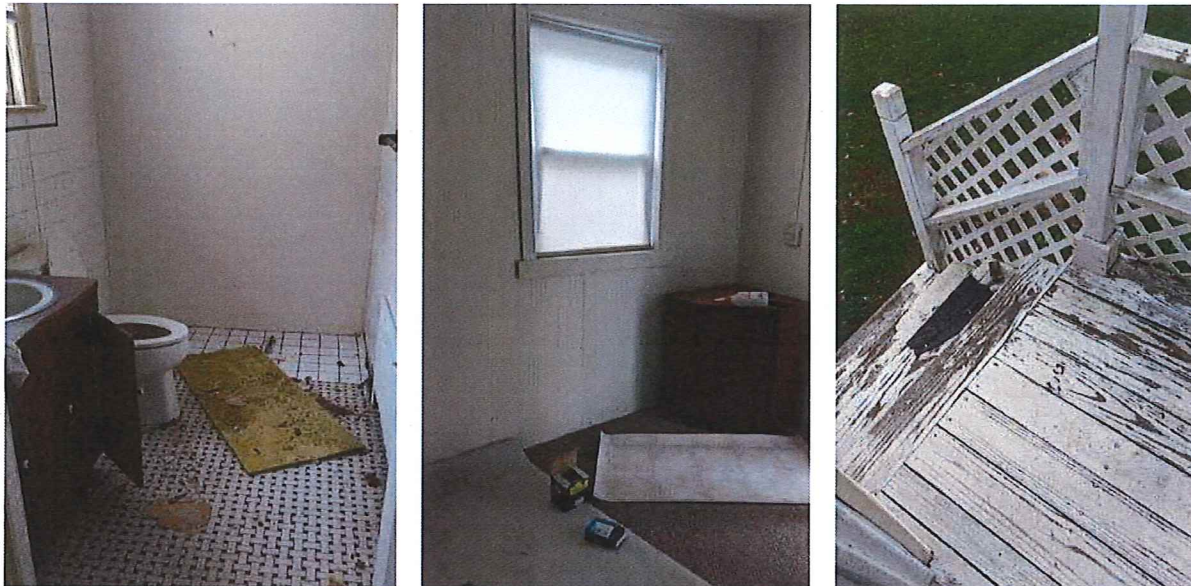
Figure 13. Block 35, Lots 6 (6.01) & 9 (9.01) - Vacant Residential Space

Bathroom at 6 Broad (left); vacant room at 2 Broad (center); dilapidated rear entry to vacant unit at 2 Broad (right).
